Manhole Inspection Summary

Manhole # S63Q__004MH

Insp Date: 11/24/08 12:39 PM

Location Address: **5600 Cardiff Ave.**

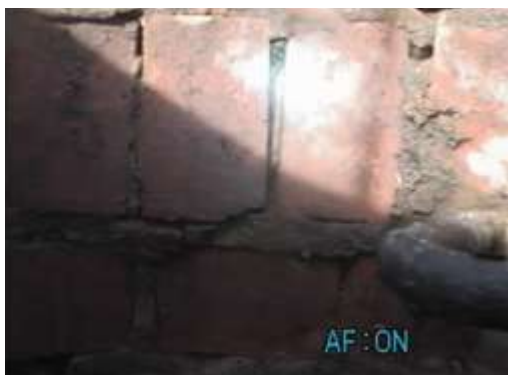
Defect 2

Debris on bench

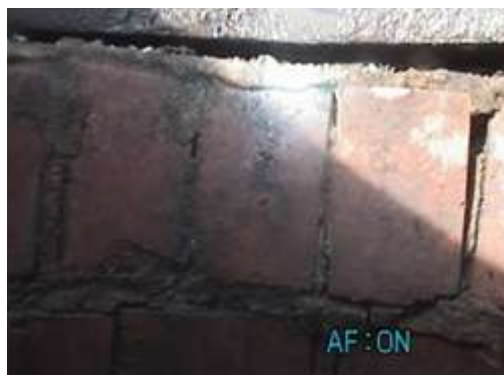
Defect 3

Condition: ☐ Sound ☐ Cracked ☐ Root Intrusion ☒ **Loose Brick** ☒ **Deteriorated**

loose bricks, mortar, joints

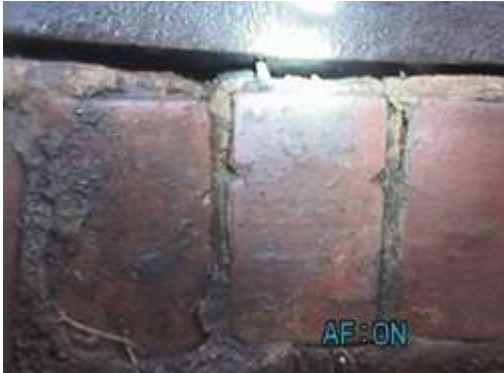
Defect 4

Frame Offset: **2.5** (in.) Condition: ☐ Sound ☐ Cracked ☒ **Leaks**

frame separation from mh

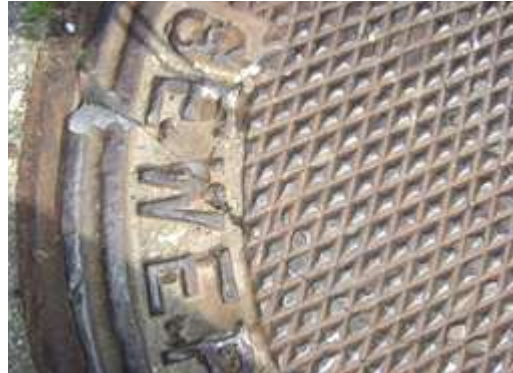
Defect 1

missing mortar at frame

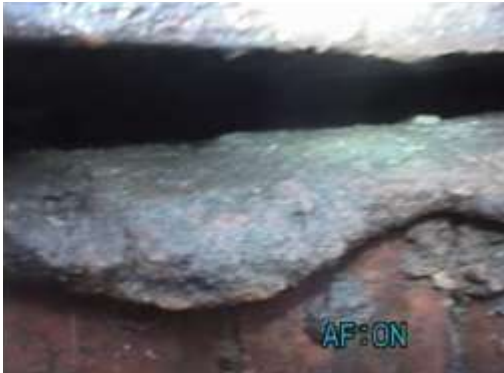
Defect 5

Crack in manhole cover

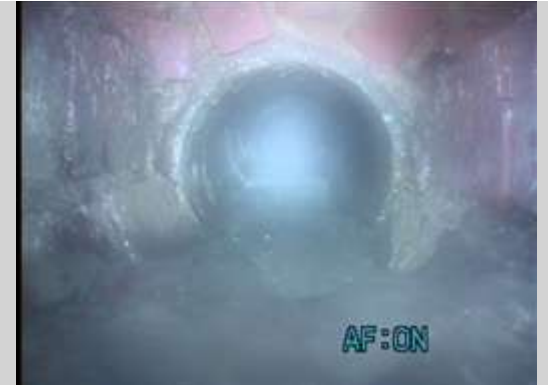
12 O'Clock Outflow

Pipe Height: **8.4** (in.) Rod and Bar (Angled)
Pipe Material: **Clay** ☐ Pipe Lined
Invert Depth: **9.67** (ft.) Flow Characteristics: **Fast**
Deposits: ☐ None ☐ Mud ☐ Sludge ☒ **Debris** ☐ Grease
Silt Depth: **0.25** (in.) Deposits Extent: **Light**
Infiltration: **None** Pipe Seal Cond: **Sound**

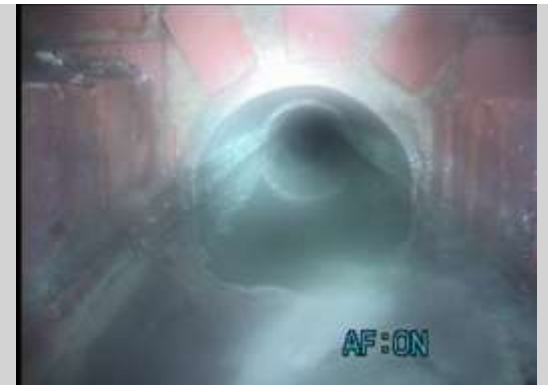
6 O'Clock Inflow

Pipe Height: **8.4** (in.) Rod and Bar (Angled)
Pipe Material: **Clay** ☐ Pipe Lined
Invert Depth: **9.75** (ft.) Flow Characteristics: **Fast**
Deposits: ☐ None ☐ Mud ☐ Sludge ☒ **Debris** ☐ Grease
Silt Depth: **0.25** (in.) Deposits Extent: **Light**
Infiltration: **None** Pipe Seal Cond: **Sound**
